Manhole Inspection Summary

Manhole # S09OO_008MH

Location Address: **2601 PIEDMONT AVE**

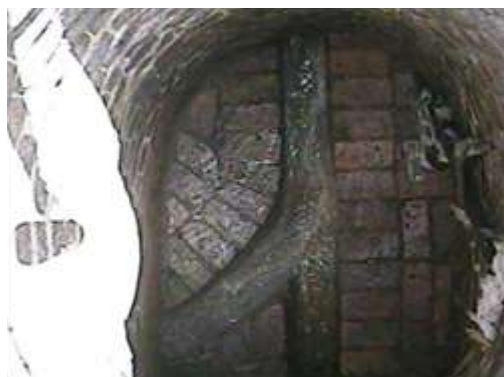
Defect 1

☒ **Evidence Of Surcharge** Depth: **5** (ft.) ☐ Active Surcharge Present

EVIDENCE OF SURCHARGE

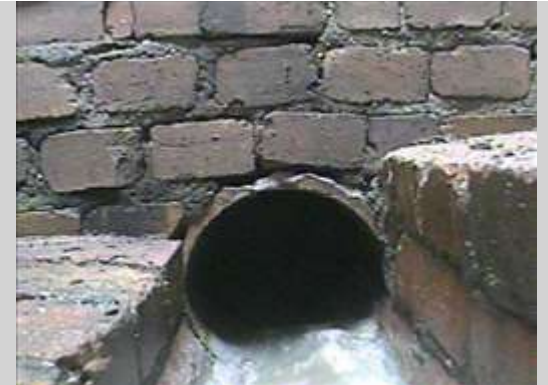
12 O'Clock Outflow

8 in. Circular Gravity Sewer
Pipe Out @ 12 O'Clock

Infiltration: **None** Pipe Seal Cond: **Cracked**

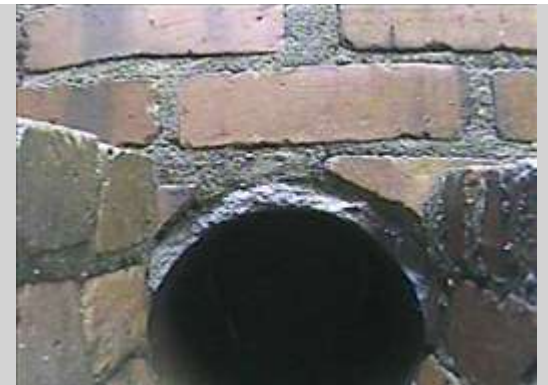
6 O'Clock Inflow

8 in. Circular Gravity Sewer
Pipe In @ 6 O'Clock

Infiltration: **None** Pipe Seal Cond: **Cracked**

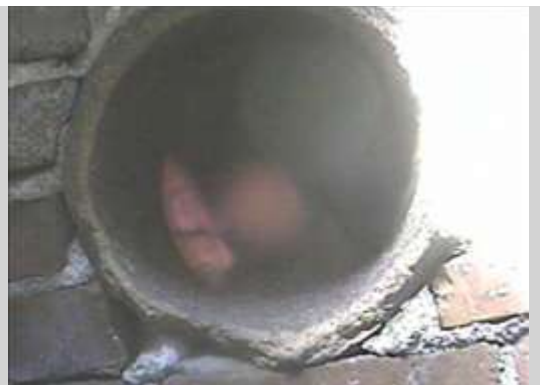
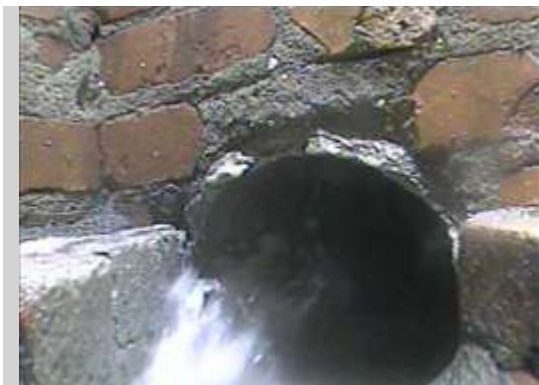
9 O'Clock Inflow

Pipe In @ 9 O'Clock

Drop In @ 9 O'Clock

Infiltration: **None** Pipe Seal Cond: **Cracked**

Drop: **Outside** **Direct**
